# Seismic Retrofit of Historic Courthouse

## Precast concrete shear walls create a lateral system

By Tim Van Zwol, P.Eng.

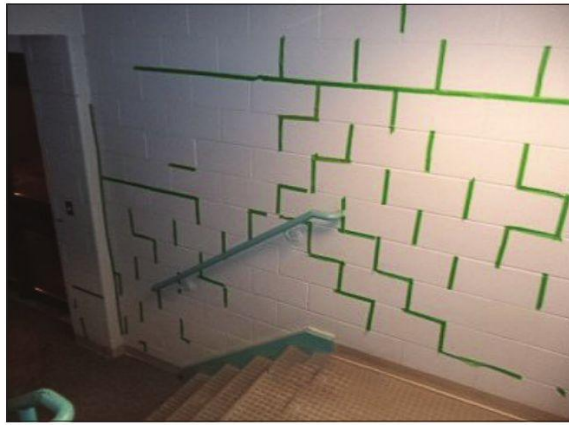
Cracking within the interior stairwell wall mortar joints and CMU was initially observed by building management staff. Prior to RJC's involvement with the building condition assessment, third-party investigations concluded there were no geotechnical or building foundation concerns at the site. RJC was initially retained in 2014 to complete a building structure condition assessment to review and document the masonry wall cracking within the stairwells. The scope of work included:

*An overview of masonry cracking within the stairwell.*

Based on the findings of the structural condition assessment, it was determined the building had no clearly defined LFRS, and the existing beam-to-column steel connections did not have sufficient lateral capacity to meet the requirements of the *Ontario Building Code (OBC)*. In lieu of a well-defined bracing system, it appeared, incidental lateral utilization of the concrete masonry walls within the stairwells was occurring, even though they were not originally intended to be part of a LFRS. Lateral engagement of masonry walls and the calculated lateral deflections under wind and

seismic loading would result in cracking. Further, it was resolved the building structure was at risk of severe damage or partial collapse if subjected to a design seismic event.

Within the stairwells, cracked masonry joints were repointed, cracked masonry units were replaced, and an elastomeric coating was applied over the entire wall surface.

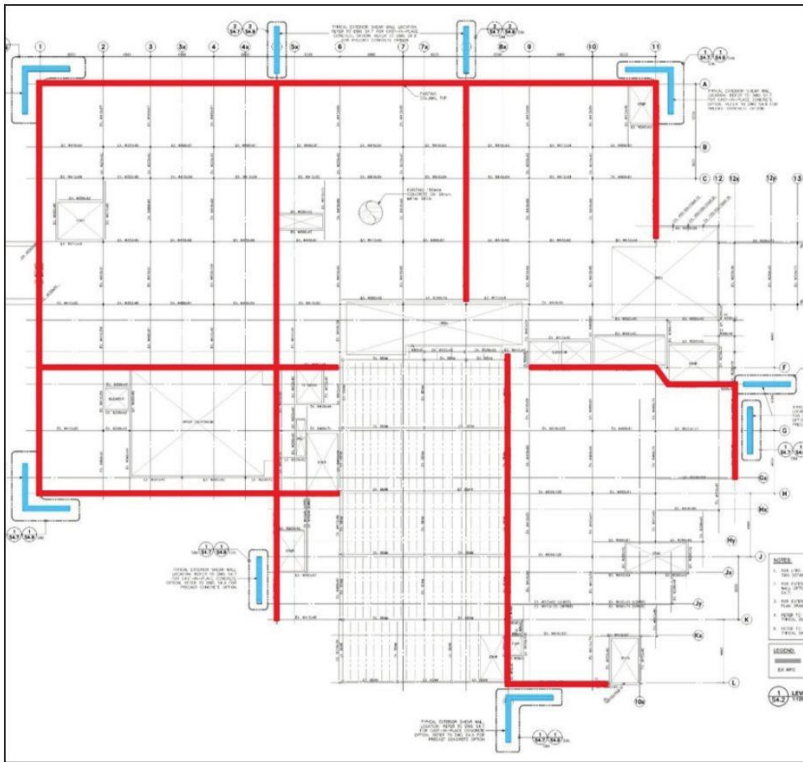
The outline of the building footprint with layout of external precast shear walls (blue) and internal steel drag struts (red).

shear walls positioned around the perimeter of the structure, with designated reinforced beam drag strut 'load paths' at the floor levels to transfer the inertial seismic forces. Nine of the precast shear walls were orientated parallel to the existing building walls and four were set perpendicular to the existing walls. Shear wall orientations and locations were selected to maximize efficiency of the new lateral system.

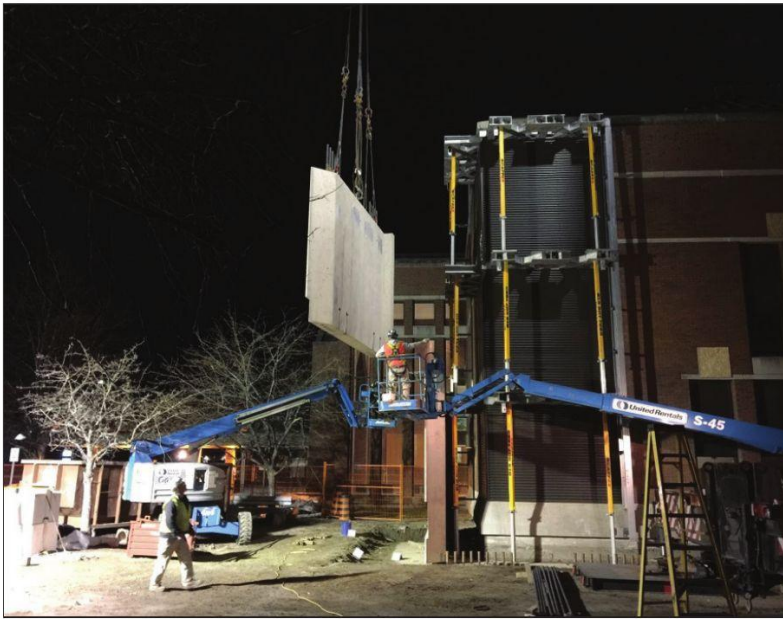
*Shear wall installation during construction.*

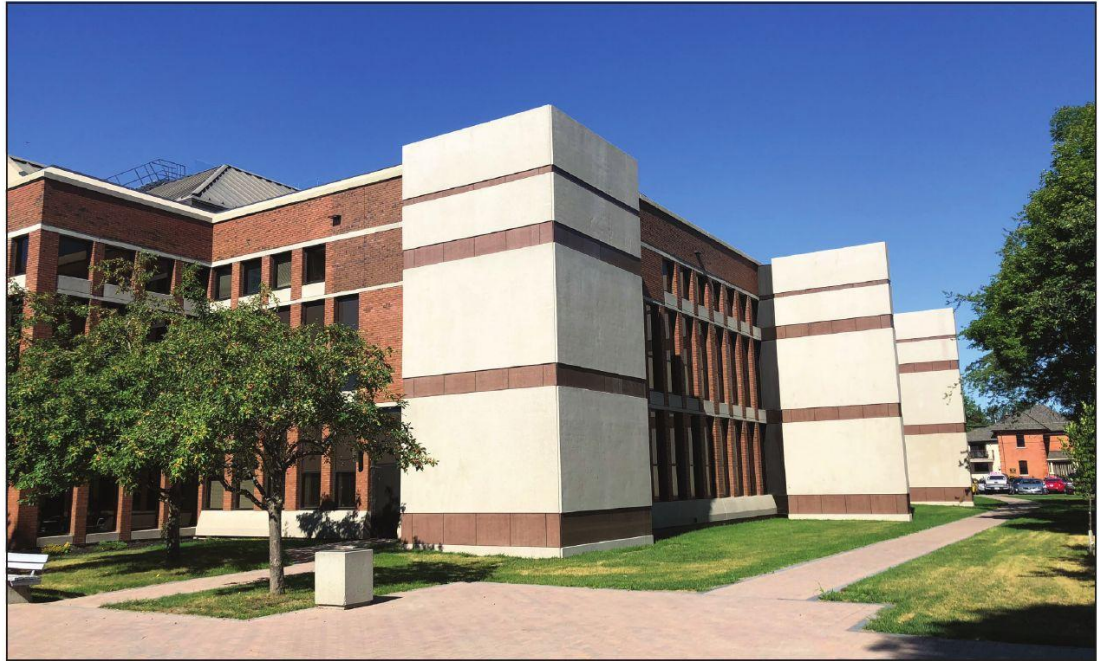
Each of the shear walls consisted of three vertically stacked segments to meet handling and shipping requirements from the precast plant to the site. The walls were cast with embedded steel plates to facilitate beam connections to the building structural steel frame, and were strengthened with internal reinforcement and post-tensioned threadbars with couplers to interconnect the vertically stacked wall panels. At the construction joint between the panels, a 75-mm (3-in.) deep recess was formed on the exterior face to accommodate architectural granite panels. The construction joint recess and granite panel covering matched the elevation of the existing building precast bands in between the windows. As one of the main architectural features of the new precast shear walls covering the construction joints and threadbar grout ports, the granite panels also complemented the building esthetics by matching the existing brick veneer.

Overview of typical shear walls with granite panel recesses.
