# INFLUENT CHANNEL AT EDMONTON'S GOLD BAR WWTP SUCCESSFULLY REPAIRED

By **Daryl Prefontaine**

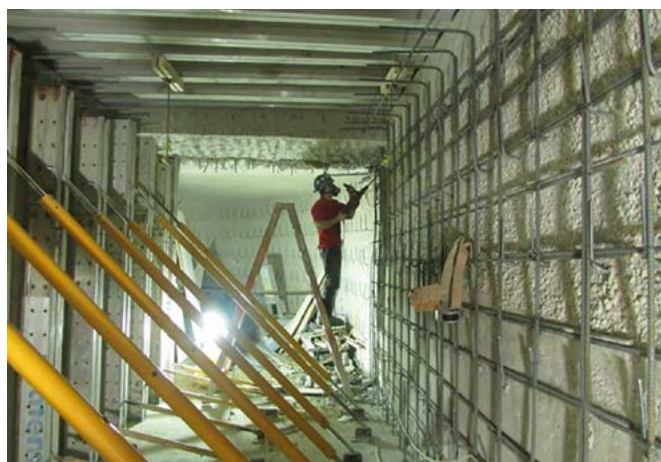
*Ensuring the safety of personnel in the enclosed influent channels adds to the complexity of an already challenging project.*

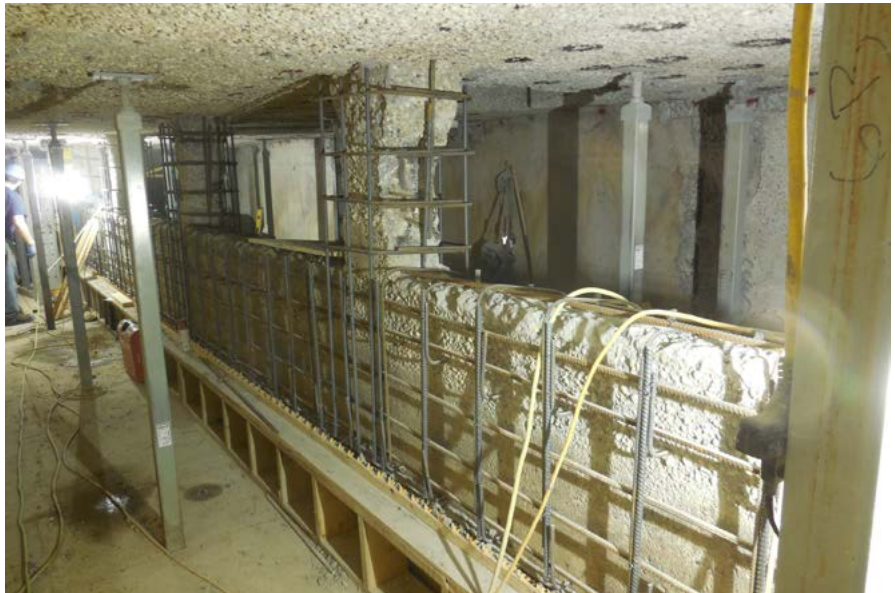
*Overlay reinforcement on the Influent Channel No. 2's overflow weir.*

reinforcement and concrete overlay materials. A cast-in-place, bonded, reinforced concrete overlay was installed to the affected portions of the channel's interior roof and wall surfaces. A minimum overlay thickness of 114 mm was provided at the underside of roof slabs, and to designated portions of sidewall surfaces, to no less than 406 mm below the lowest water level. In much of the channel length, the entire wall height was covered with the new overlay system to improve constructability and detailing.

The overlay thickness was designed to provide the 51 mm concrete cover required by ACI 350, plus provide sufficient depth for installation of hooked steel dowels and reinforcing bars. A highly durable, sulfate resistant, self-consolidating concrete mix was specified to provide the low shrinkage, low permeability, pumpable concrete necessary for the overlay construction and subsequent environmental exposure.

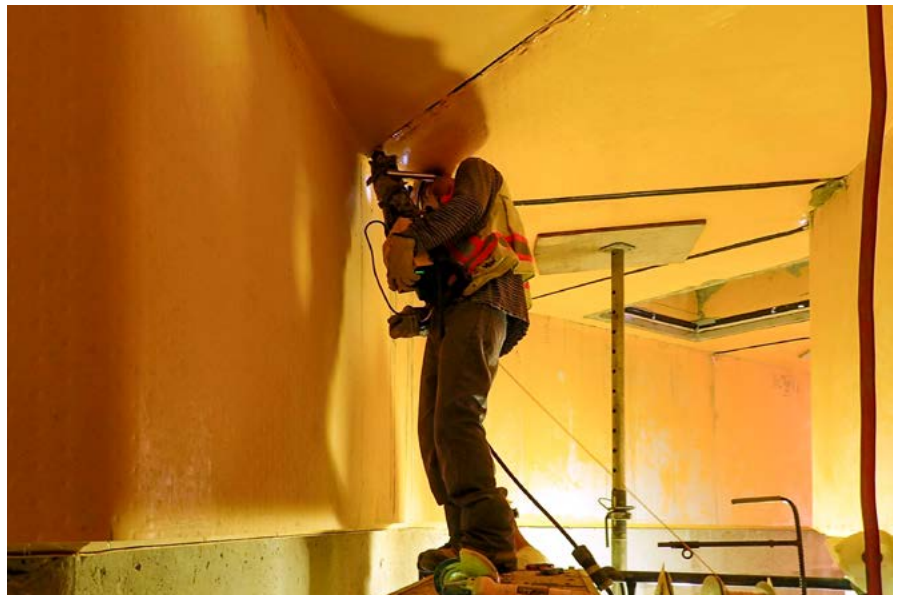
Field welding of the HDPE liner was done with an extruded welding rod of the same HDPE material.

The HDPE liner is produced in long rolls, which requires that all edges be field-welded to provide the final watertight assembly after removal of the construction formwork materials. Field welding was performed using an extruded welding rod of the same HDPE material along the length of the liner's prepared edge joints. High voltage spark testing was performed along all field welds to ensure that a watertight liner assembly was provided.
