REPAIR AND LONG-TERM PROTECTION OF WASTEWATER INFRASTRUCTURE: GOLD BAR INFLUENT CHANNEL NO. 2

BY DARYL PREFONTAINE

Gold Bar Influent Channel No. 2 Structural Repair Edmonton, Alberta, Canada

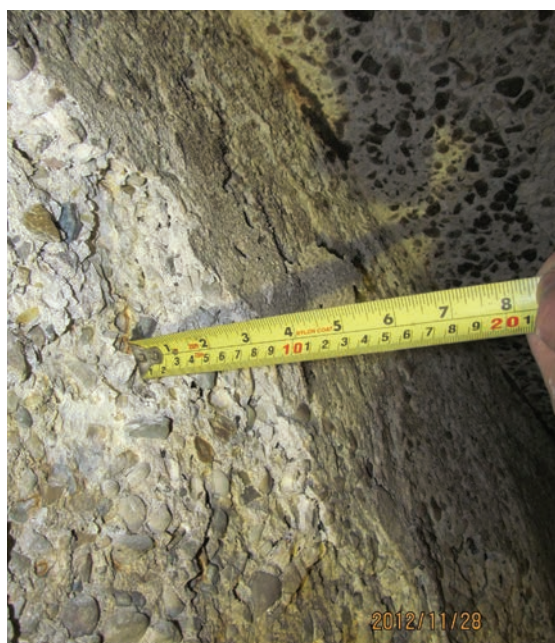
Fig. 1: Extensive depth of concrete deterioration on channel walls

During an interior inspection of Influent Channel No. 2 in 2014, after approximately 35 years of service and H_2S exposure, between 1.25 to 3 in (32 to 76 mm) of deteriorated and unsound concrete was identified on many interior surfaces during hammer-sounding of the channel walls, columns and roof members (Fig. 1 and 2). The extent of deterioration varied from the roof to the low water level, up to the full interior height of the channel walls in some locations. Significant erosion and loss of concrete wall thickness had occurred in many locations, often to the depth of the reinforcing steel (Fig. 3). Similarly, the concrete cover on the underside of the roof slabs had deteriorated to expose the lower mat of reinforcing steel in many locations. Beam stirrups and bottom layer reinforcement steel were also exposed and heavily corroded, with visible loss of cross-sectional area.

The Influent Channel's original construction details provided approximately 1.5 to 2 in (38 to 51 mm) of concrete cover over the embedded steel reinforcing steel. Therefore, the severe extent of concrete cover loss, the resulting reduction in concrete member thickness, and loss of reinforcing steel cross-sectional area were considered to be of structural concern in the affected areas, causing a significant reduction in load-carrying capacity.

- Installation of a cast-in-place, bonded, reinforced concrete overlay to the affected portions of the channel's interior roof and wall surfaces. A minimum overlay thickness of 4.5 in (114 mm) was provided at the underside of roof slabs, and to designated portions of sidewall surfaces, to no less than 16 in (406 mm) below the lowest water level. In much of the channel length, the entire wall height was covered with the new overlay assembly to improve constructability and detailing (Fig. 6 and 7);

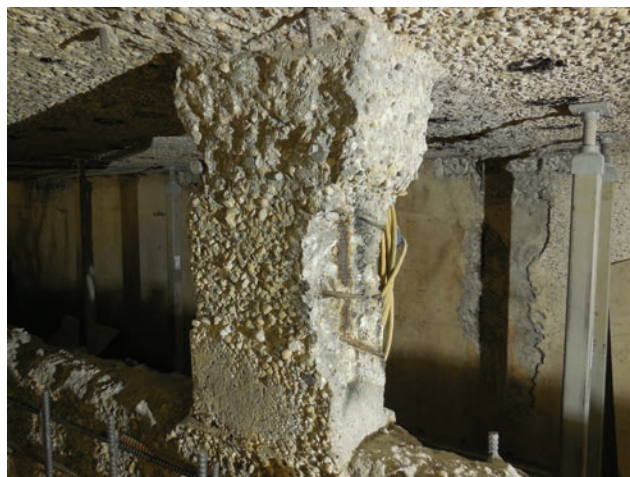
Fig. 2: Existing column deterioration

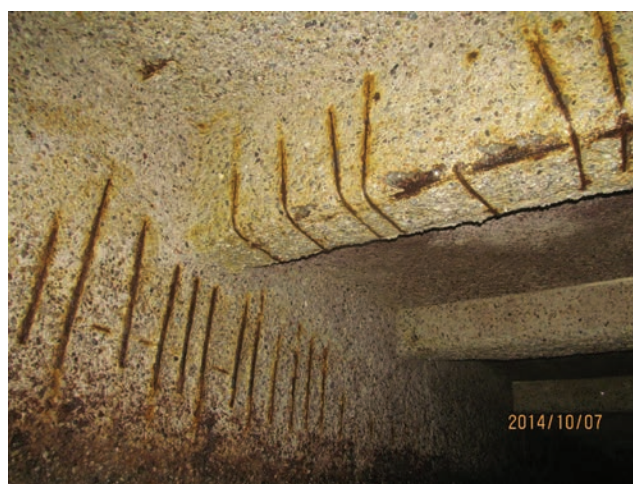
Fig. 3: Exposed reinforcing steel at beam and wall surfaces

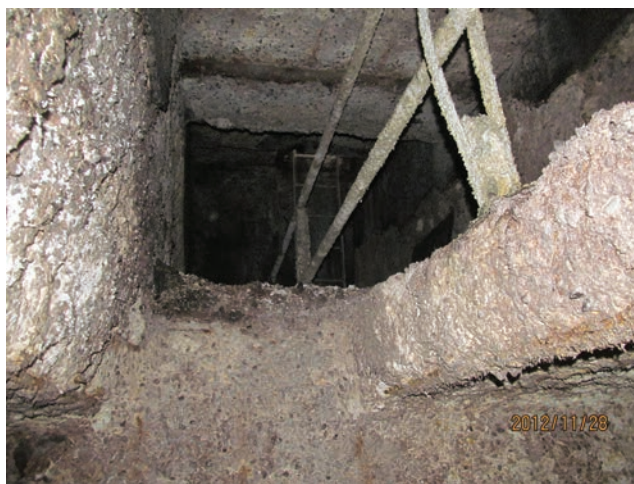
In addition to the structural concrete deterioration, the inspection revealed that expansion joint seals were missing or damaged and thus no longer effective, and that metal gratings and handrails were severely corroded above the wastewater flow level (Fig. 4).

Fig. 4: Severe corrosion of metal railings above wastewater flow

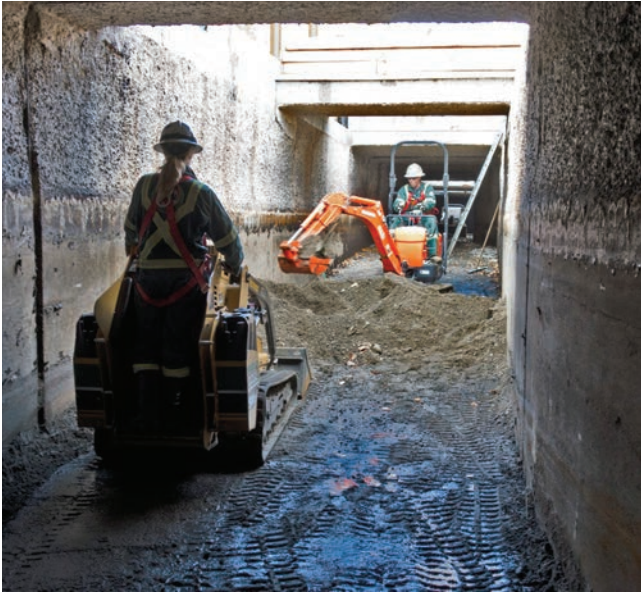
Fig. 5: Initial removal of channel debris

- Removal of channel debris (Fig. 5), removal of deteriorated and unsound concrete, and substrate surface cleaning and preparation to a CSP 5 concrete surface profile, in accordance with ICRI Guideline 310.2R¹, prior to the placement of new reinforcement and concrete overlay materials;

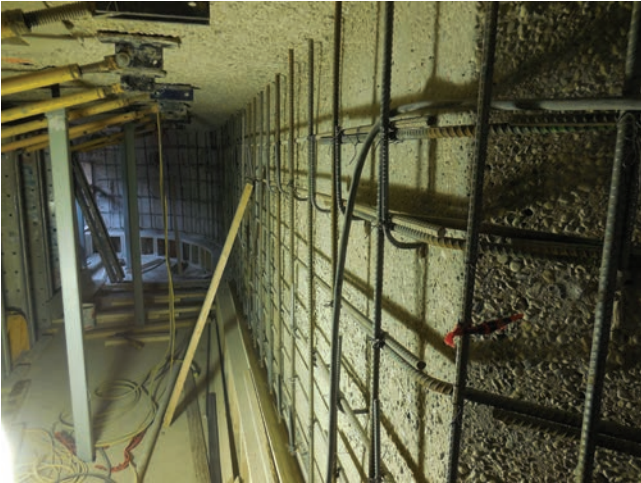
Fig. 6: Wall reinforcing and bracing

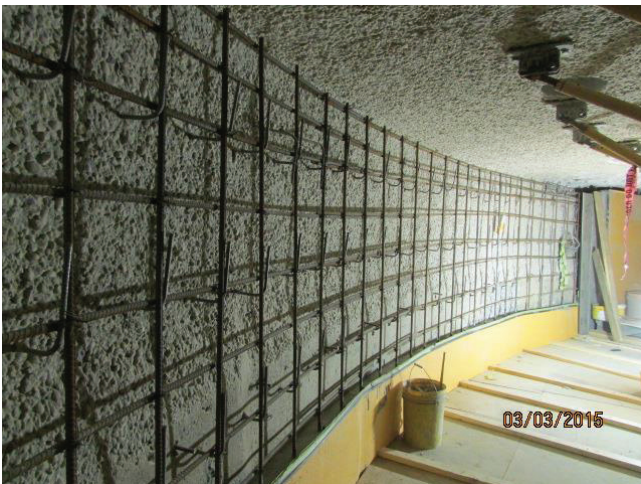
Fig. 7: Reinforcing and base of HDPE liner at curved wall

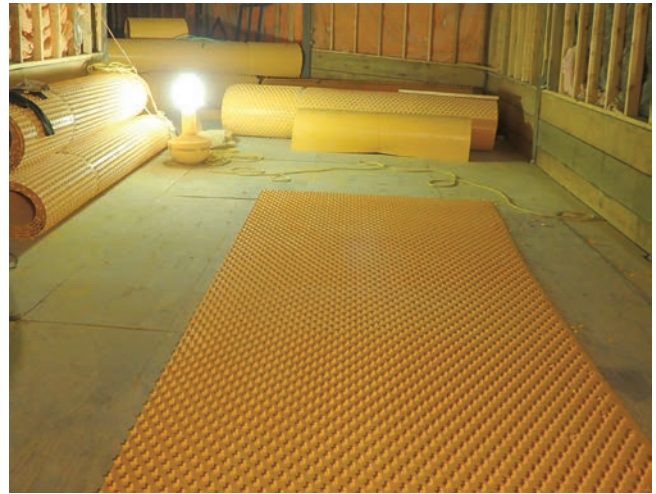
Fig. 8: Preparation of HDPE liner for installation

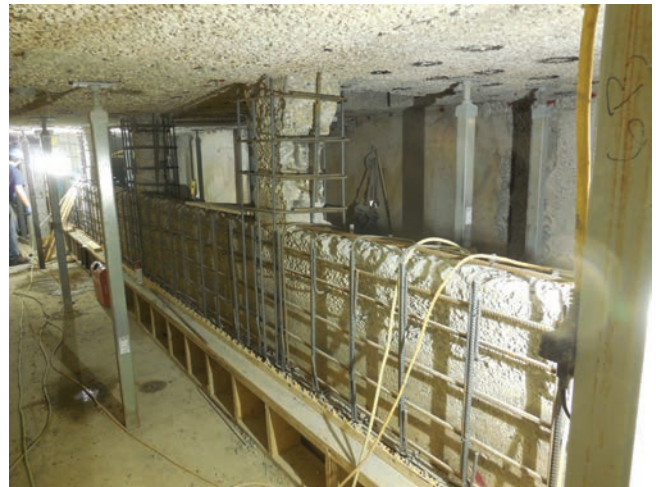
Fig. 9: Formwork, bracing and drilling of reinforcing dowels

The structural design of the new concrete overlays was intended to provide fully composite behavior between the undamaged portions of the existing structure and the new concrete overlay, through material bonding and sufficient reinforcement dowelling at the shear interface (Fig. 9 and 10). The recently-developed ACI 562-13⁴ Repair Code Requirements provided valuable guidance for the design, bond interaction, and required transfer of forces between the existing concrete channel and the repair overlay assembly. Other considerations and requirements for design of the concrete overlays in this application were identified in ACI 350, including concrete cover, reinforcement ratio and spacing requirements.

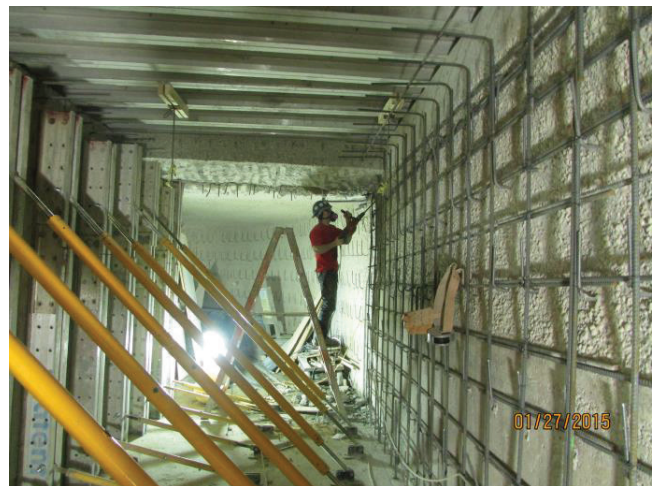
Fig. 10: Overlay reinforcement at overflow wier

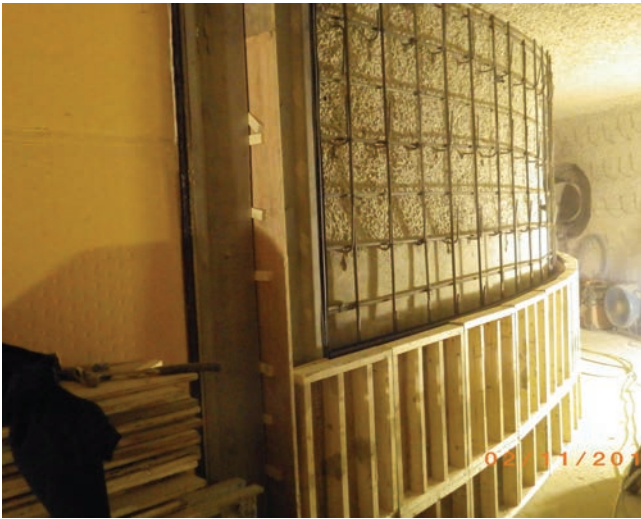
Fig. 11: Wall liner, reinforcement, and formwork

The construction of the bonded overlay and HDPE protective liner assembly also provided some challenges for the contractor (Fig. 11 and 12). It was necessary to ensure that formwork and

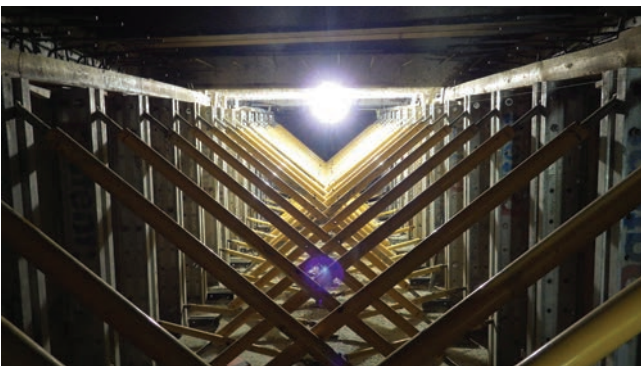
Fig. 12: Formwork and bracing

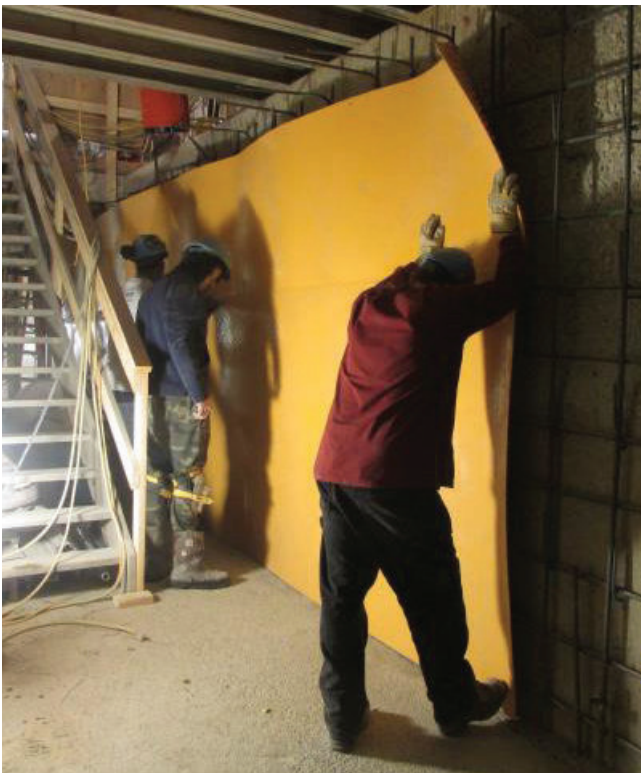
Fig. 13: Trial fit of HDPE liner prior to erection of formwork

bracing systems introduced the fewest possible number of penetrations through the protective liner, to minimize liner patching requirements before returning the channel back into service. Additionally, the lack of formwork tiebacks into the concrete substrate also introduced the challenge of ensuring that the layer of HDPE liner did not wrinkle or warp during placement of the self-consolidating concrete overlay materials (Fig. 13).

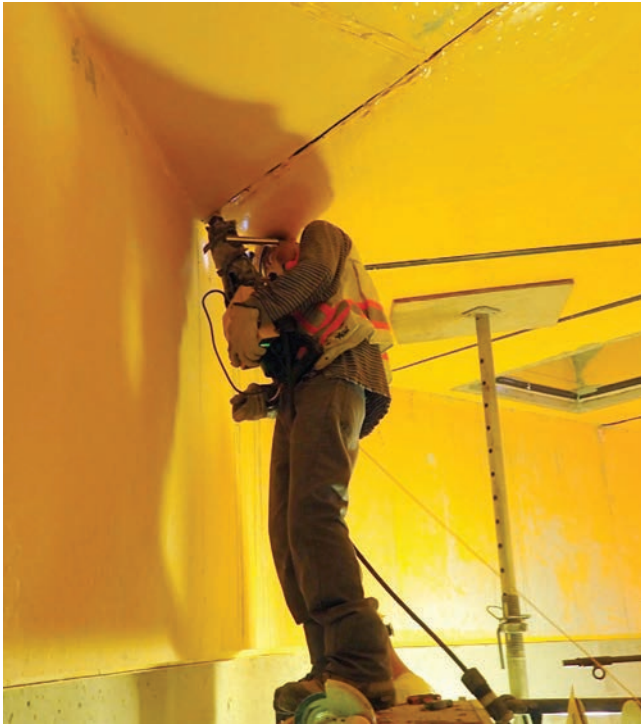
Fig. 14: Field welding of HDPE liner seams

The HDPE liner is produced in long rolls, which requires that all edges be field-welded to provide the final water-tight assembly after removal of the construction formwork materials. Field welding was performed using an extruded welding rod of the same HDPE material along the length of the liner's prepared edge joints (Fig. 14). High voltage spark testing was performed along all field welds (Fig. 15) to ensure that a watertight liner assembly was provided. In addition to the spark testing and visual inspections of the installed protective liner, testing requirements for the project included daily tensile testing of welded liner splice samples, plus tension and shear pull-testing of representative samples of the installed hooked reinforcement dowels (Fig. 16).

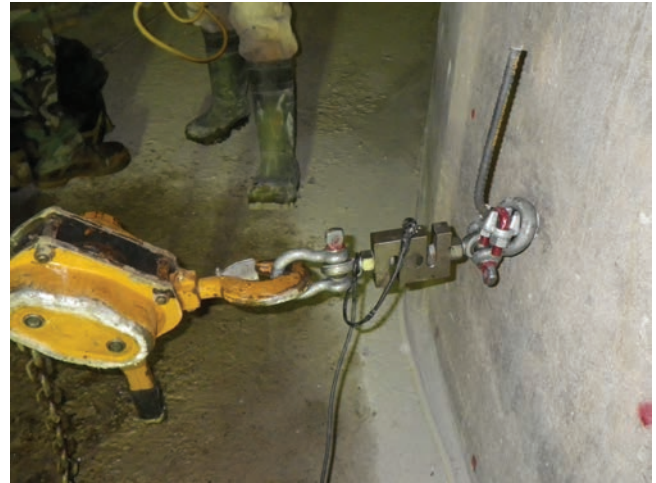
Fig. 16: Load testing of dowels

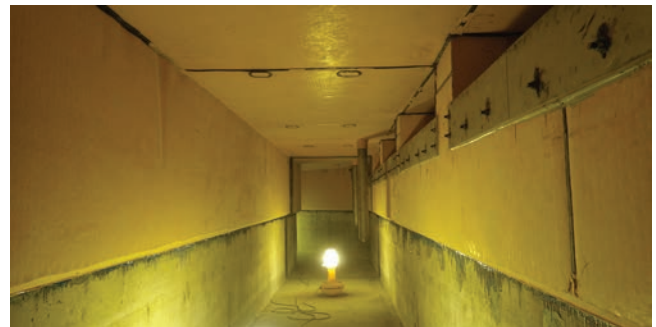
Fig. 17: Nearing completion of overlay and HDPE liner assembly at overflow wier

In an existing wastewater influent channel with significant deterioration and loss of concrete thickness at the roof and wall members, the construction of a new bonded concrete overlay with integral HDPE protective liner assembly was successfully achieved (Fig. 17) to restore and enhance the channel's load-carrying capacity, and to provide appropriate long-term protection against harsh environmental exposures in the future. The date of substantial project completion was May 25, 2015.

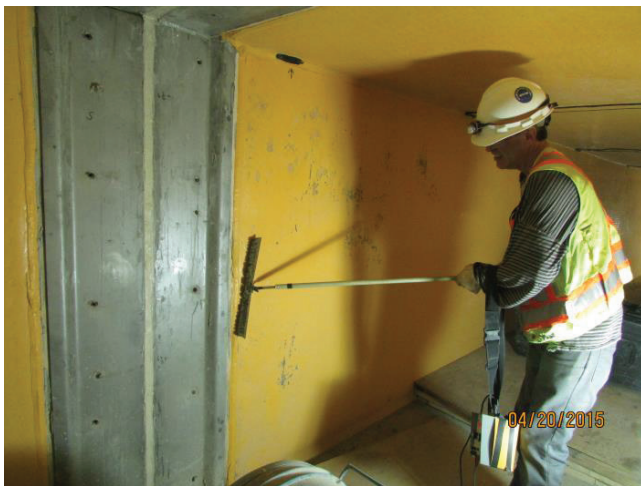
Fig. 15: Spark testing of completed HDPE liner welds
