Shining a New Light on the Riddle of Shear

by Jack J. Poldon, Neil A. Hoult, and Evan C. Bentz

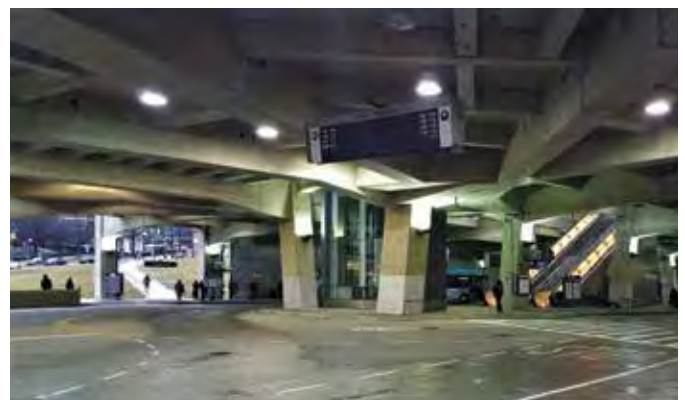
Fig. 1: Transfer girders at the Paul S. Sarbanes Transit Center in Spring City, MD, USA (photo courtesy of Evan Bentz)

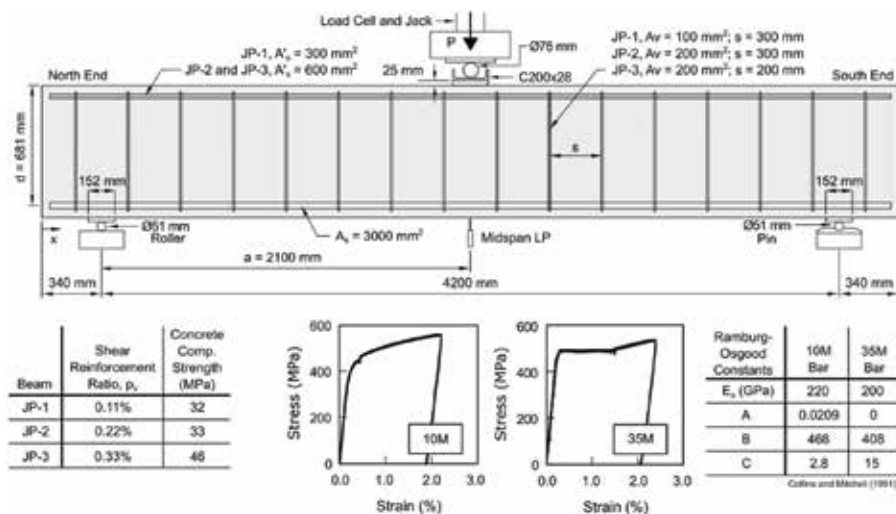
Fig. 2: Test set-up, reinforcement for the three beam specimens, and material properties

This study focused on three reinforced concrete beams named JP-1, JP-2, and JP-3 which were designed with varying shear reinforcement, as summarized in Fig. 2 and tested in three-point bending. Specimen JP-1, which contained slightly

As shown in Fig. 2, the beams were tested in three-point bending with an overall span on-center of 4200 mm. Thus, with an effective depth (d) of 681 mm, the shear span-to-depth (a/d) ratio was 3.1, meaning the specimens were slender beams from an analysis point of view. The beams were loaded in displacement control at a rate of 1 mm/min with a 2000 kN capacity hydraulic jack. Loading was paused every 50 kN for approximately 20 minutes so the DFOS and DIC measurements could be recorded. In addition to the distributed sensors, linear potentiometers (LPs) measured the beam displacements at midspan while the applied load was measured with a load cell as shown in Fig. 2.

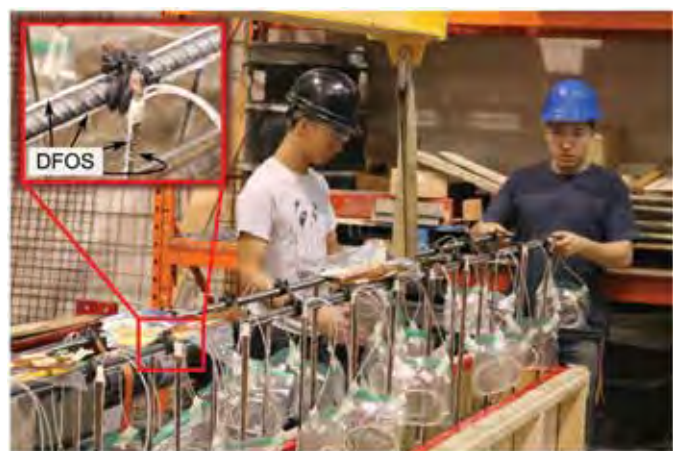
Fig. 3: Reinforcement cage of specimen JP-2 being lowered into the forms prior to concrete casting with DFOS bonded to the 20M reinforcement and 10M stirrups visible

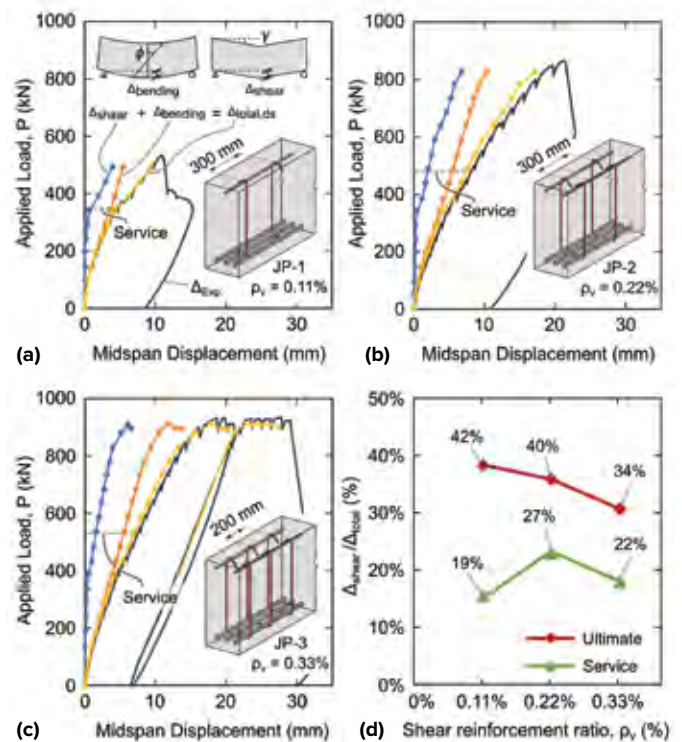
Fig. 4: Load versus midspan deflection responses: (a) load-displacement of JP-1 with a depiction of shear and bending components; (b) JP-2; (c) JP-3; and (d) shear displacement as a percentage of total displacement at service and ultimate loads

The load (P) versus midspan deflection responses (Δ_{Exp} curves) of the three beams are summarized in Fig. 4(a) through (c), which shows that JP-1 and JP-2 experienced brittle shear failures, while JP-3 underwent flexural yielding before an anchorage failure was observed at the north end.⁵ Because these Δ_{Exp} measurements represent the total displacement from a displacement transducer placed at the midspan of the beams, Δ_{Exp} includes both bending deformations from curvature and shear deflections from shear strains, though the latter are usually ignored by designers. Distributed sensing enables the bending and shear deflection components to be decoupled as they were measured independently.

As seen in Fig. 4(a) through (c), the total beam deflections calculated from the distributed measurements ($\Delta_{total,ds}$) are in good visual agreement with those obtained directly from the linear potentiometers placed under the beams' midspan. Additionally, until an applied load of about 400 kN, the total beam deflections were primarily due to bending because the beams had not yet developed shear cracks. However, as significant diagonal cracks developed, the shear deflection (Δ_{shear}) became non-negligible. This meant that at service conditions, the shear deflection represented about 25% of the total (where service conditions were taken as 60% of the ACI 318 estimated member strength), as seen in Fig. 4(d). The percentage of total deflection attributable to shear ($\Delta_{shear} / \Delta_{total,ds}$) was found to increase with applied loading, where at the ultimate load it represented up to 42% for specimen JP-1. The proportion of total deflection due to shear at the ultimate load went down as the shear reinforcement ratio increased partly because JP-3 did not fail in shear, but also because higher shear reinforcement levels result in lower shear strains for a given shear stress. It can be concluded from Fig. 4 that curvature plus shear strain is sufficient to model overall member displacement in a transfer girder, and many designs of such members are likely systematically underestimating displacements by ignoring shear strains.

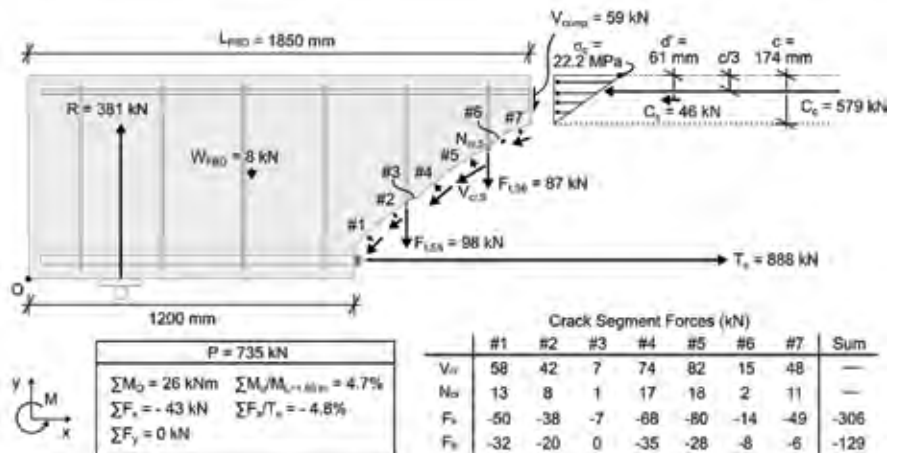
Fig. 5: Free body diagram (FBD) of beam JP-2 at P = 735 kN, where force components are calculated from DFOS strain and DIC crack width and slip measurements

Based on the distributed measurements and material models, this approach resulted in an FBD that is close to being in equilibrium, with a 26 kN·m imbalance in the moment and -43 kN imbalance in the x-direction. When these imbalances are compared to the applied moment at the cut face ($M_{L=1.85\text{ m}}$) and the tension steel force ($T_s = 888\text{ kN}$), the FBD is only imbalanced by about 5%, which given the potential variation in parameters such as the modulus of elasticity and the stress carried along the crack is very promising. In this analysis, the y-direction is in perfect equilibrium because the remaining vertical force was set to equal the unknown shear force in the flexural compression region (V_{comp}). At $P = 735\text{ kN}$, V_{comp} represented 15% of the reaction force (R) which is close to the ~20% value that Mörsh¹⁴ predicted over 100 years ago.

The FBD being close to equilibrium without modifications to the constitutive models implies a number of conclusions: 1) there is shear carried in the flexural compression region of members with stirrups, but it is a relatively small contribution; 2) it is realistic to assume, for slender members like these with stirrups, that the concrete contribution (V_c) is the integral of aggregate interlock stresses along the crack plus the small compression region force; and 3) the source of the stirrup contribution to shear strength (V_s) is the force in stirrups crossing the cracks. Note that the pair of fiber optic cables on each bar allowed bar bending and dowel action in stirrups and flexural reinforcement to be evaluated. These forces were found to be small¹⁰ and thus are not shown in Fig. 5.

In addition to the core conclusions previously mentioned, another observation from the FBD in Fig. 5 comes from the magnitude of the flexural compression and tensile forces. It is apparent that the tension force arrow ($T_s = 888\text{ kN}$) and combined compression force arrows ($C_c + C_s = 625\text{ kN}$) are unequal. Indeed, the difference of 263 kN is 10 times the self-weight of the beam and thus much more than a measurement error. The reason this occurs is that the aggregate interlock forces on the crack provide a vertical component carrying shear but also a significant horizontal component.

One cause of the difference in the tension and compression forces in the FBD of Fig. 5 is because these regions are not just resisting flexure but also shear. This mechanism is highlighted in the DFOS strain measurements of the top and bottom reinforcements in a combined distributed measurement (CDM) plot in Fig. 6.⁸ This figure shows the DFOS strains spaced every 10 mm along the longitudinal reinforcement bars from JP-2 at an applied point load of 735 kN. The measured tensile (shaded in blue) and compressive (shaded in green) DFOS

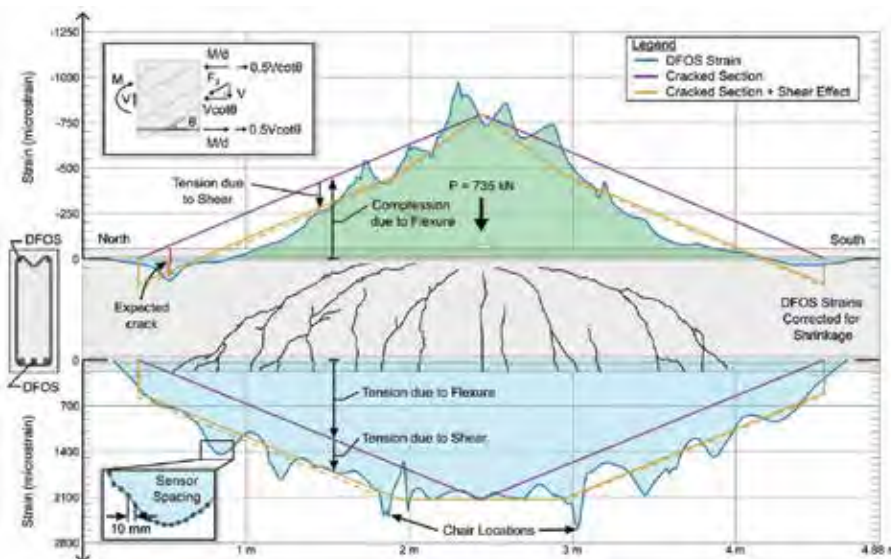
Fig. 6: Combined distributed measurement (CDM) plot of specimen JP-2 at $P = 735\text{ kN}$ with compressive and tensile reinforcement strains

strains are compared to predictions based on several cracked section analyses (the purple and gold lines). The CDM is plotted with the corresponding cracking pattern, which contains diagonal cracking on both shear spans. The DFOS strains from the tensile reinforcement are not linear with beam length due to tension stiffening effects along the bar. However, the measured DFOS strains also do not follow the transformed cracked section estimate, drawn in purple and labeled as Cracked Section. Generally, the tension reinforcement DFOS strains were significantly higher than the Cracked Section strains, while the compressive reinforcement strains were significantly lower than the Cracked Section strains, particularly away from midspan.

This effect, sometimes called a moment shift, can be explained by the inset FBD in Fig. 6. If the member is assumed to be diagonally cracked with a series of parallel cracks, a field of diagonal compression will form in the web of the member to carry the shear, which also results in an additional horizontal force of $V \cot \theta$. This horizontal compressive component is centered in the web and thus can be modeled as resisted by two additional horizontal tensile forces of $0.5V \cot \theta$, one at the level of the tension reinforcement and the other within the flexural compression region. The Cracked Section + Shear Effect prediction with the gold line fits the measured DFOS strain data more closely than a flexure-only approach. Thus, the argument that the difference in horizontal flexural forces on the top and bottom of the section are caused by aggregate interlock stresses is only part of the story: locally at the crack they are caused by aggregate interlock, but on average they can also be derived directly from the shear stresses themselves assuming only that the member is diagonally cracked. This sort of triangulation of evidence suggests that the analysis in this article is on the right track.

A critical parameter in the Cracked Section + Shear Effect prediction is the angle of principal compressive stress (θ). In the case of the Cracked Section + Shear Effect prediction in Fig. 6, θ was taken as 45 degrees, which ACI 318 recommends for shear design.¹⁵ An alternative approach is to determine the average angle of diagonal principal compressive stress experimentally through fitting the Cracked Section + Shear Effect prediction to the DFOS tension reinforcement strain.^{10,12} This approach was applied to the data in Fig. 6, as indicated by the dashed gold line. At $P = 735$ kN in Fig. 6, θ was found to be 28 degrees on the north span and 31 degrees on the south span. This hints at a potential opportunity to refine Code approaches and will be discussed further.

on the compressive side reduces the measured strain to such an extent that tension is both measured and predicted in the top chord of the beam, where the bending moment is small near the support. This behavior can be seen in Fig. 6, where over the north support, a location exists where the compressive reinforcement strain exceeds the cracking strain of the concrete and, thus, a crack was likely present, though it was too small for the authors to locate. This leads to an interesting consideration for design, in that reinforcement is required in an area where one might typically assume it is not needed for flexure alone.

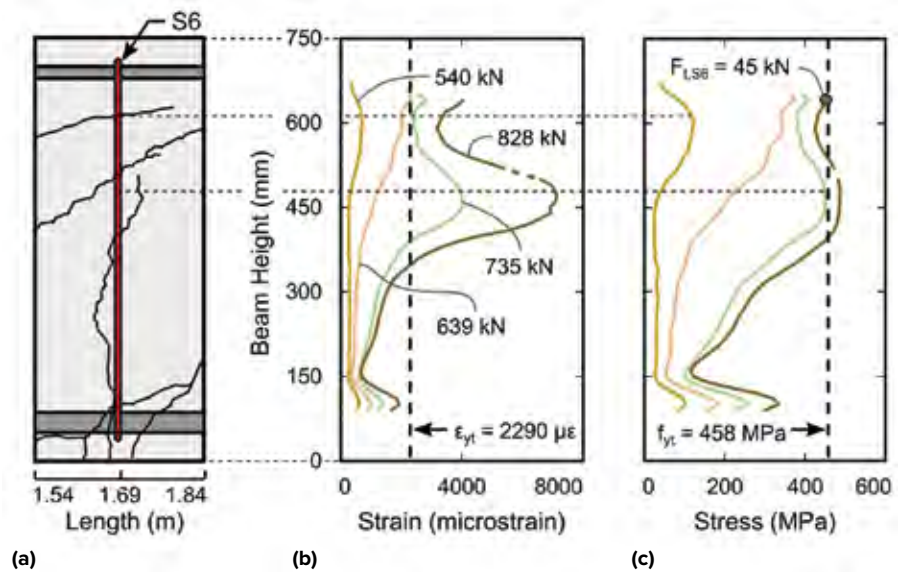
Fig. 7: Demand of stirrup JP-2 S6: (a) cracking pattern at JP-2 S6 location; (b) DFOS strains; and (c) reinforcement stresses

Meanwhile, the stresses in the stirrup are shown in Fig. 7(c). The distributed stress profile for the stirrup was more constant over the height versus the strain response, particularly at the highest applied load levels (735 kN and 828 kN) and where the shear cracks crossed near the top of the member. This is in line with the ACI 318 Code provisions for stirrup forces at ULS conditions where it is assumed the stirrups will yield. It is also apparent from Fig. 7(c) that the demand near the top

hook of the stirrup was high, equaling 45 kN (98% of yield) at ULS. This meant the demand on the 135-degree stirrup hook was high even though the hook was on the flexural compression side of the member but also in flexurally uncracked concrete. This observation was found for many stirrup leg measurements from JP-1, JP-2, and JP-3, where diagonal shear cracks crossed near the top of the stirrup leg, highlighting the importance of proper stirrup detailing even in the uncracked flexural compression region.

the ~4 kN shear force at ULS is small relative to the 45 kN tension force measured at the top of the east stirrup leg in Fig. 7(c), this demonstrates the potential that distributed sensors offer in terms of understanding and indeed quantifying complex shear behavior.

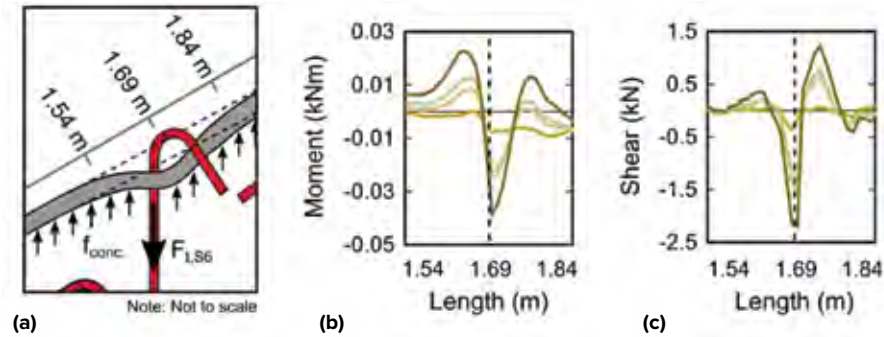
Fig. 8: Impact of high hook forces: (a) schematic of anchorage-induced compression bar bending; (b) measured moment of 20M compressive reinforcement; and (c) measured shear of 20M compressive reinforcement

The impact of these high hook forces can also be seen in the flexural compression reinforcement strains, where the stirrup anchorage force induced bending as depicted in Fig. 8(a).^{5,8} Because the observed bending in Fig. 8(b) must have an associated shear force diagram, the approximate amount of shear transmitted by the stirrup hook to the compressive reinforcement can be found as presented in Fig. 8(c) (total shear force measured from peak to trough). While

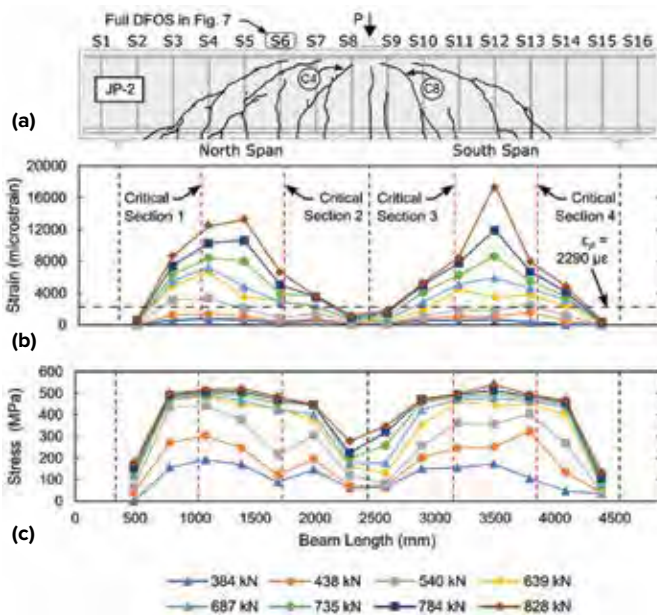
Fig. 9: Peak stirrup demand for all stirrups in JP-2: (a) cracking pattern for JP-2 at ULS; (b) strains from DFOS; and (c) stresses

While Fig. 7 shows the DFOS measurements of a single stirrup leg, Fig. 9 summarizes the peak demand of all the stirrups in specimen JP-2 for loads after shear cracking. The measured peak strains averaged between the two stirrup legs are presented for the 14 stirrups in Fig. 9(b)

while the corresponding stresses are plotted in Fig. 9(c). Figure 9(b) shows how increasing the applied load resulted in increased stirrup strains generally, where the maximum was found in the critical region for shear design (d from the supports and point load as in ACI 318). The highest measured strain was in S12 at the ULS load stage ($P = 828$ kN or 96% of the peak load), where the strain exceeded 16,000 microstrain or 1.6% strain in the shear span where the shear failure was observed. The lowest stirrup strains were measured where the shear force diagram approached zero or switched signs in the S2 and S15 stirrups near the support plates and the S8 and S9 stirrups near the load plate.

The peak stirrup stresses, however, tell a different story where the stirrup stress demand was essentially constant along the entire shear span. This occurred because the stirrups were almost all yielding for most of the load levels as shown in Fig. 9(b) and (c), except near the disturbed regions at the member ends. Importantly, the stirrups were observed to yield as early as $P = 540$ kN (62% of the peak load), clearly demonstrating that reinforced concrete members do not fail once a stirrup first yields—a common misconception. Additional applied load can be resisted due to the rotating angle of the principal compressive stress field, when considered in an average sense, or with additional shear on the crack, when considered locally at the crack.

Another finding from Fig. 9(c) is how high the peak stresses increased for the stirrups nearest to the point load (S8 and S9), which is a region where lower demand in the stirrups might be expected since they were within a distance (d) of the load plate. However, because cracks C4 and C8 turn towards the point load, the cracks intercept S8 and S9, causing nearly 400 MPa of stress at ULS conditions. Meanwhile, clamping action prevents cracks from forming near the pin and roller supports, explaining why the measured strains and stresses are relatively lower for S2 and S15.

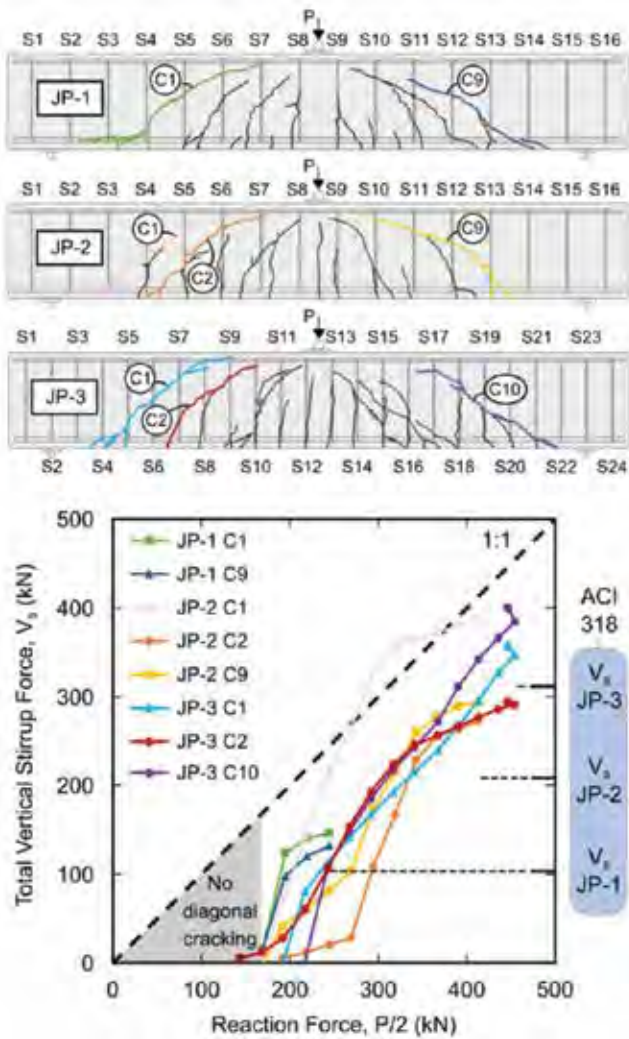
Fig. 10: Measured V_s with load calculated using DFOS strains for eight shear cracks from JP-1, JP-2, and JP-3, compared to ACI 318 Code predictions

(V_s) can be quantified. The experimentally determined V_s for eight shear cracks in beams JP-1, JP-2, and JP-3 are presented in Fig. 10. The curves represent the cumulative stirrup forces which cross the shear cracks determined from the DFOS strain measurements. For example, for crack JP-3 C1, the V_s curve is made up of a total of four stirrups, where V_s is the total stirrup force from stirrups S5 to S8. As expected, the V_s was approximately zero for the three beams before shear cracking. But once shear cracking occurred, the V_s for most cracks does not equal the reaction force (they are below the 1:1 line in the figure). Therefore, some other mechanism must contribute to resisting shear even at low applied loads, namely the concrete contribution V_c . However, in the case of crack JP-2 C1, the V_s exceeds the applied shear for some load levels. This is attributed to the flatter portion of crack JP-2 C1 requiring high enough normal compressive stresses on the crack interface to allow V_s to exceed the reaction force. In Fig. 5, these normal stresses are labeled N_{cr} and can be seen

The behavioral differences in the shear crack V_s curves between the three beams show interesting trends worthy of a closer look. Generally, the shear resisted by V_s for JP-1 and JP-2 begin to plateau as the loading approaches ULS, while JP-3 has a more linear response up to ULS. This was because the stirrups of JP-1 and JP-2 were yielding, as shown in Fig. 7 and 9 for JP-2, and thus the value of V_s was limited while for JP-3, the member reached flexural yield prior to a shear failure, limiting the demand on V_s . Figure 10 shows that immediately after diagonal cracking, the concrete and stirrup components (V_c and V_s) both contribute to the shear resistance. Given that the V_s curves are approximately parallel to the 1:1 applied load line, the amount of V_c was reasonably constant during loading until the stirrups started to yield. At this point, the V_s term could not increase; thus, any additional shear must have been resisted by V_c alone. Eventually, this mechanism would also reach a limit as higher loads are associated with wider cracks and lower aggregate interlock capacity, so eventually the cracks would begin to slip uncontrollably—a shear failure.

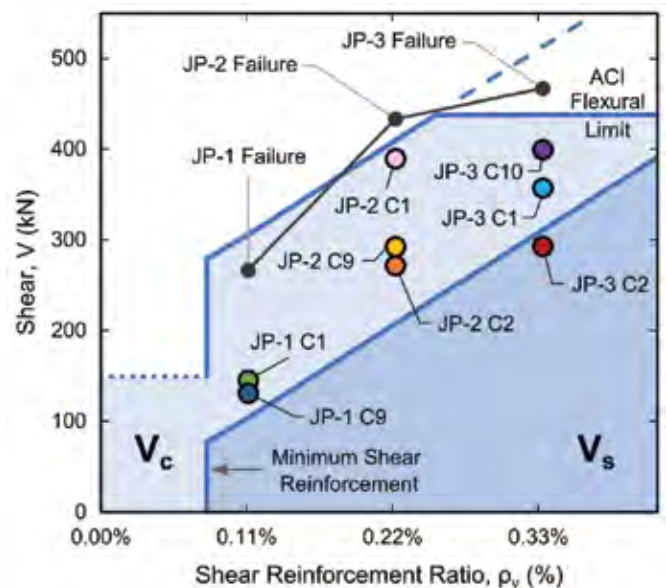
Fig. 11: Measured V_s of JP-1, JP-2, and JP-3 cracks at ULS conditions compared to $V_s + V_c$ estimate from ACI 318, and failure load of three beams

The experimentally measured V_s values at ULS conditions from Fig. 10 are compared to the predictions of shear resistance ($V_n = V_s + V_c$) from ACI 318 in Fig. 11. For this study, all safety factors equalled unity. For the three shear reinforcement ratios tested, ACI 318 provided reasonable but fairly conservative estimates for V_s . Other design methods, such as the CSA¹⁶ or “AASHTO LRFD Bridge Design Specifications,”¹⁷ assume lower values of θ and thus predict a higher value of V_s closer to the average behavior shown in

Fig. 11.¹⁰ Figure 11 shows via the black line that the ACI Code made good predictions of the failure load, where the code-to-experimental failure load ratio was between 0.94 and 1.14. The other codes, CSA and AASHTO, produced similar predictions of failure load where the code-to-experimental failure load ratio was between 0.90 and 1.11. While each method provided similarly good $V_s + V_c$ predictions, the ACI Code has a lower V_s term, meaning that it must also have a higher V_c value than the other codes in order to produce a similar sum. The recent drop of the V_c value of members without stirrups in ACI 318-19 due to the size effect could be related to this difference as well, though more study is required to know if this is true in general.
