Wood balconies 101

By Stacey McDougall, P.Tech.(Eng.), LEED AP BD+C, NCSO

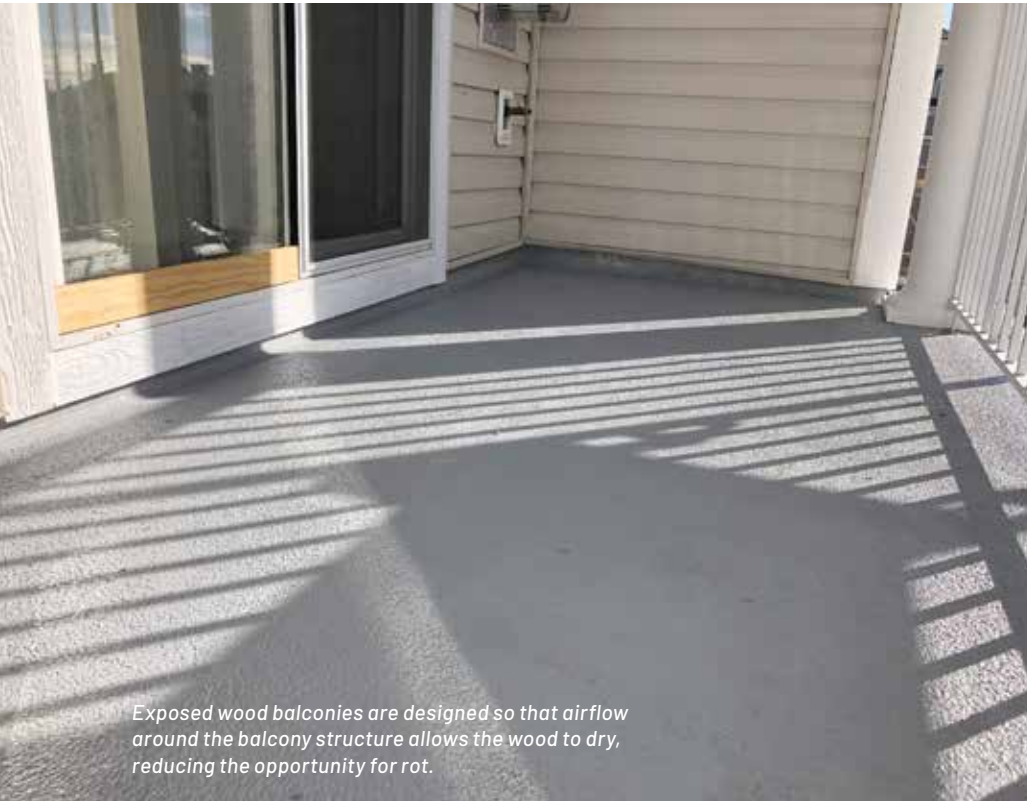
Exposed wood balconies are designed so that airflow around the balcony structure allows the wood to dry, reducing the opportunity for rot.

Exposed wood balconies are designed so that airflow around the balcony structure allows the wood to dry, reducing the opportunity for rot. Wood elements should be painted or stained regularly to protect the wood and any structural members with rot or that are heavily curled/cracked and replaced during painting programs. Alternately, the wood structure may be covered, typically with either a vinyl membrane or a liquid-applied pedestrian deck coating. The vinyl membrane is susceptible to damage from sharp objects, which may include furniture feet. Both types of membranes will be damaged if objects are scraped

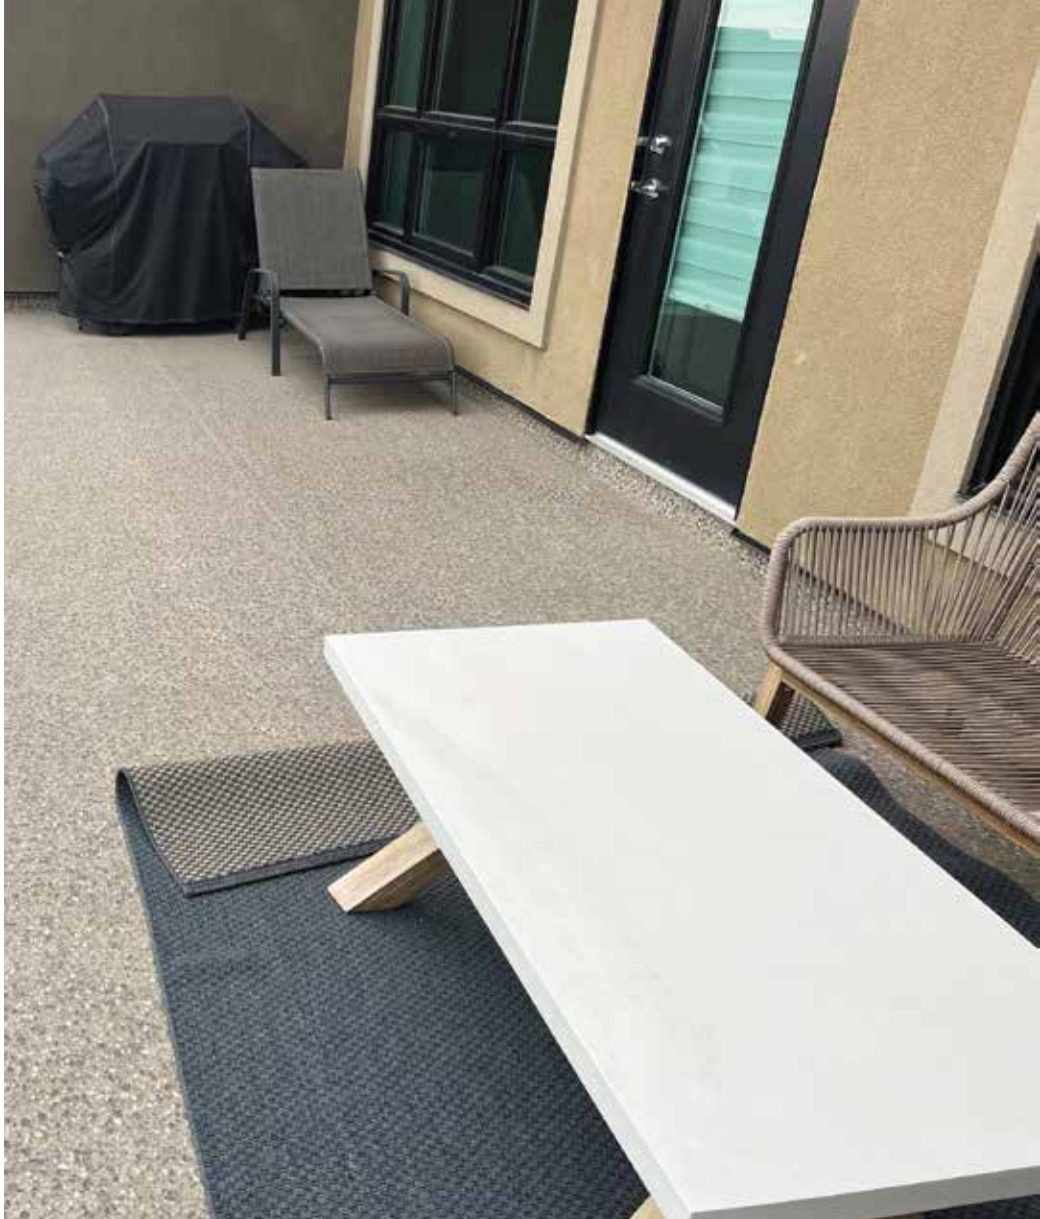
Any soft spots on a wood balcony should be reported to the condominium board, as these may indicate rot in the deck sheathing and pose a safety hazard.

Any soft spots on a wood balcony should be reported to the condominium board, as these may indicate rot in the deck sheathing and pose a safety hazard. Repairs to wood structure rot are expensive, and depending on the structural design of the building, may involve work inside units, which is disruptive to residents. Early identification of issues will prevent structural damage and reduce repair costs significantly, which benefits everyone. A building envelope consultant can assist in identifying areas of concern and ensure replacement/maintenance programs incorporate best practices for durability and longevity.
