# Factors to Consider when Redesigning **Podium Decks**

By James Cooper, P.Eng., LEED AP

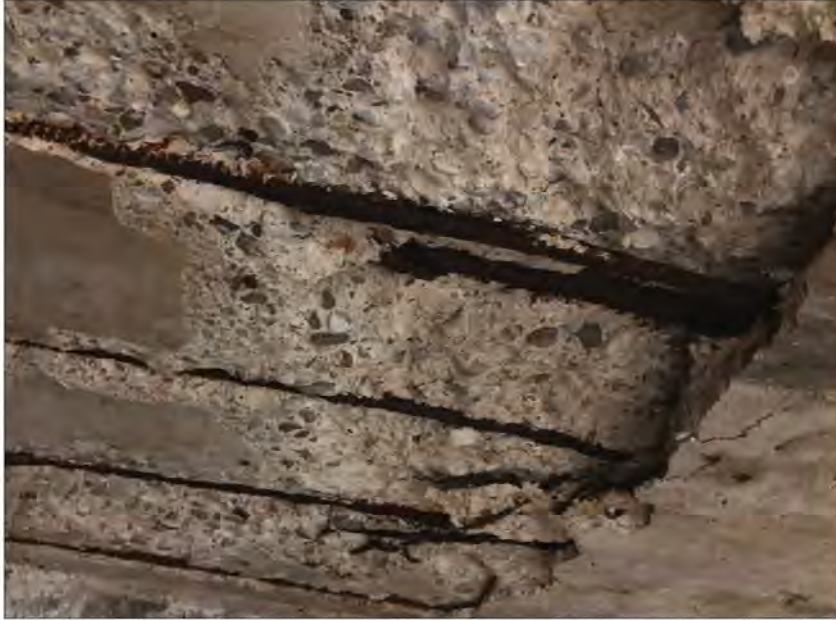
*Structural deterioration as a result of a failure of the podium deck waterproofing system.*

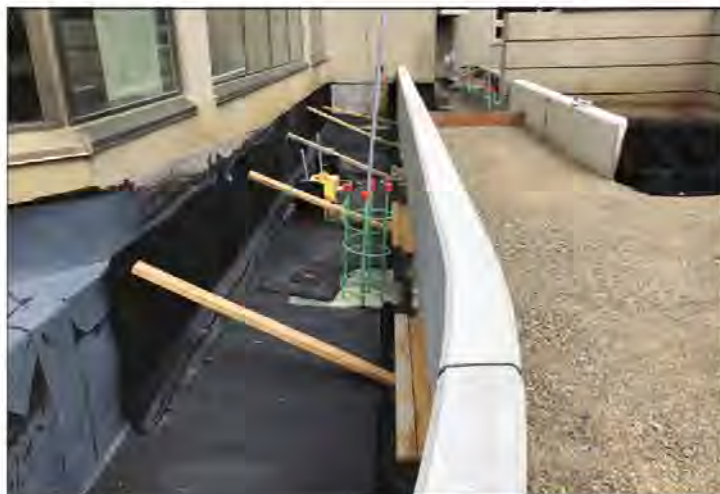
Cross-sectional view of overburden installed on a podium deck at a condominium located at 30 Greenfield Avenue in Toronto.

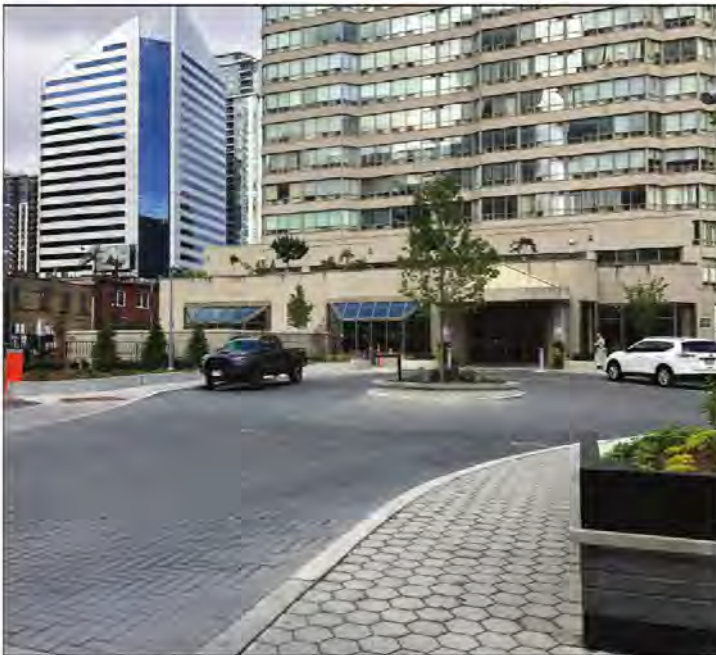
Completed podium restoration at 30 Greenfield Avenue.

The owner is MTCC No. 877 with property managers Crossbridge Condominium Services. The prime consultant and structural engineers were RJC Engineers, MWLA Landscape Architects was the landscape architect, and the contractor was Macdero Construction (Ontario). The original design for this podium deck left very little room for vehicles to pick-up/drop-off people without obstructing the entire circle. Additionally, it lacked a safe sidewalk on the west side of the property where most pedestrian traffic travelled. The design incorporated the creation

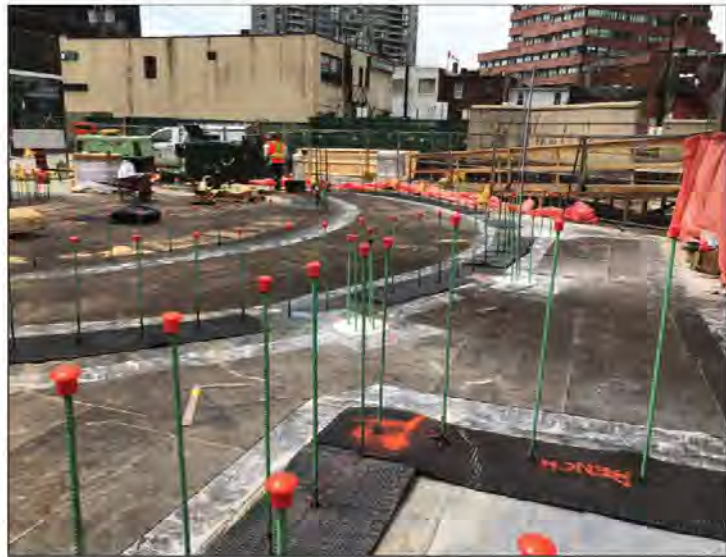
Ongoing installation of liquid-applied, hot rubberized waterproofing.

have a squeegee-applied hot rubberized asphalt waterproofing membrane overlain with a protection and drainage layer. In two-ply systems, the hot rubberized asphalt waterproofing is reinforced with inter-ply fabric reinforcing sheets.

Liquid-applied hot rubberized asphalt systems have useful installation characteristics—particularly, they can be easily installed at changes in elevation, over concrete curbs, and up perimeter walls. They also allow for simple tie-in details at drains and other termination points. When installed with appropriate protection courses, overburden can be readily installed with little risk of damage. The waterproofing work can also be completed in phases, with tie-in to previously installed waterproofing completed with a simple lap that provides a watertight seam.
