When Corrosion Leads to Structural Distress

Tips to spot, prevent and repair structural deterioration in your older stock building

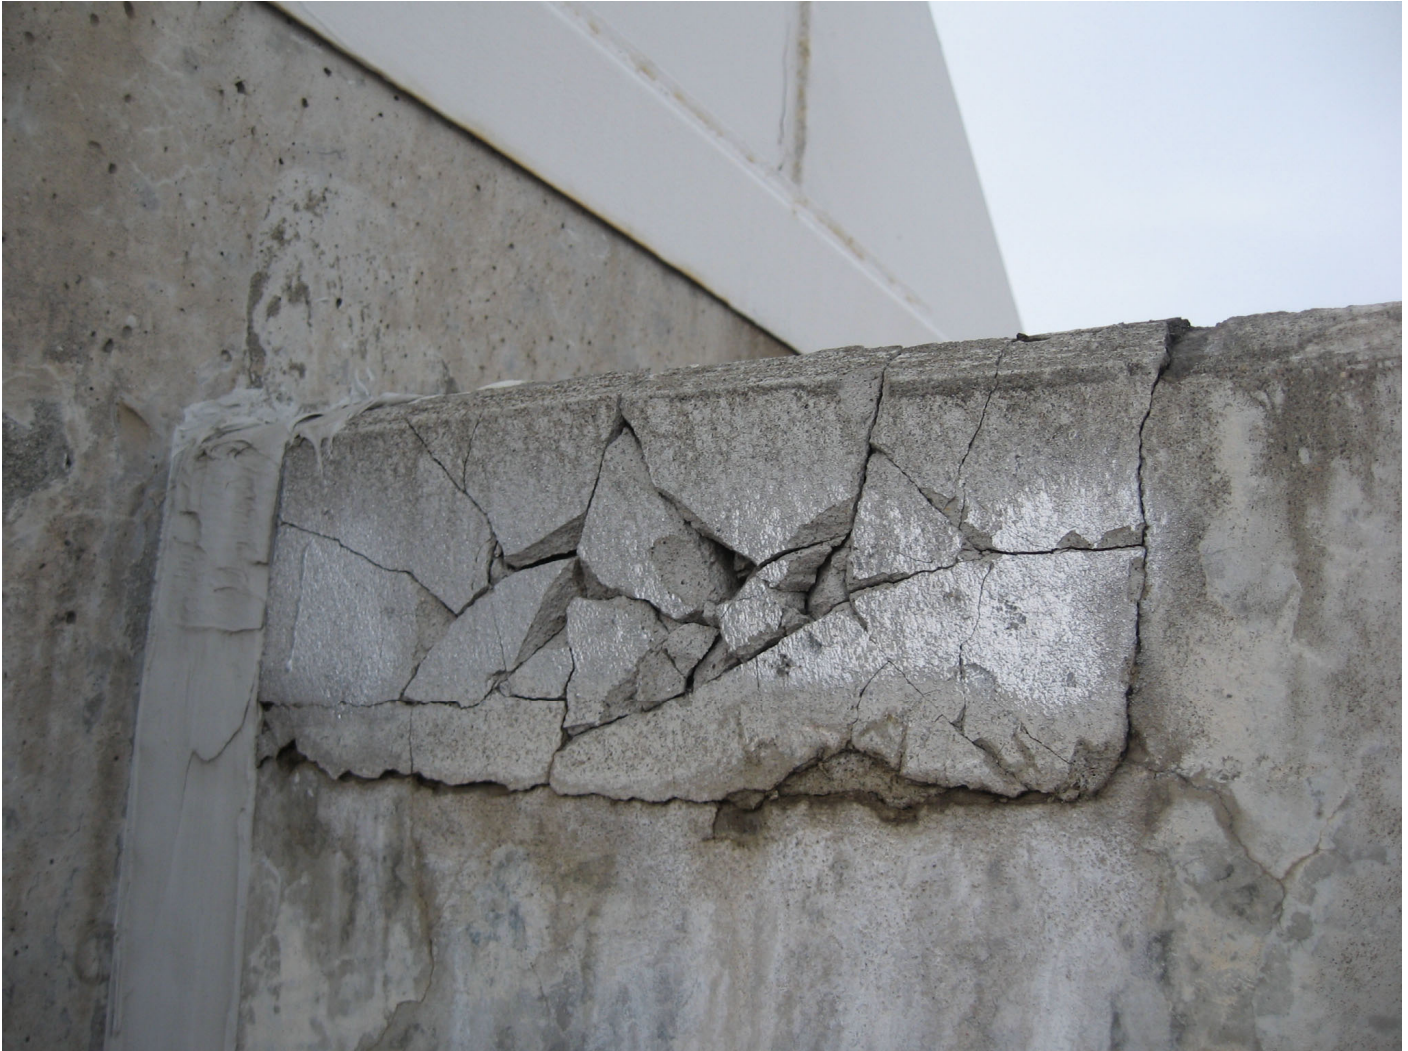
Typically the first sign of deterioration in concrete is the appearance of cracking, followed by spalling in the areas where more progressive reinforcing steel corrosion has occurred. The spalling of the concrete will often expose the reinforcing steel—and once the corrosion process begins, it will continue at an accelerated rate.

“At this stage, the public’s health and safety might be at risk due to reductions in the load-carrying capacity of the structure,” Horst cautions. “Cracking, spalling and exposed reinforcing steel are tell-tale signs that the structure may be unable to safely support the loads being applied as a result of corrosion deterioration.”
